WBP9-6

Fabrication of additional deposited layer of $\text{GdBa}_2\text{Cu}_3\text{O}_{7-\delta}$ on coated conductors for joint

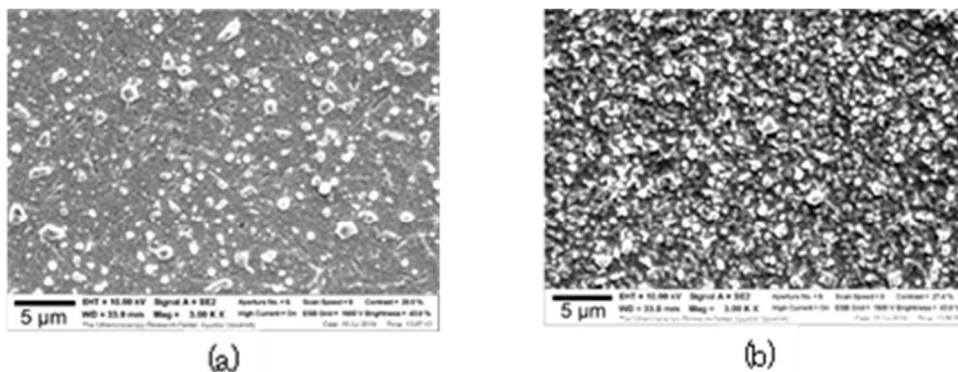
Fig.1 SEM images of film surface of GdBCO layer before (a) and after (b) additional deposition onto GdBCO CC

Additional layers were fabricated by a metal organic deposition⁽³⁾ method. Firstly, starting solutions were spin-coated onto GdBCO CCs, and the samples were calcined at 823 K. Next, they were heated at 1073 K under the oxygen pressure of 200 Pa to crystallize and oxygenated at 773 K for 2 hours. Then the film surface was observed by a Scanning Electron Microscopy (SEM). Fig.1 show SEM images of film surface of GdBCO layer before (a) and after (b) additional deposition onto GdBCO CC. The contrast difference is small in whole area in Fig.1 (a), showing smoothness. On the other hand, the contrast difference is large in Fig.1(b), showing roughness. In addition, the number of grains is large in Fig.1(b), which indicates the roughness is due to the existence of many grains. The roughness of film surface may cause voids at the joint interface of the jointed sample. It is necessary to fabricate additional layer with smooth surface to increase I_c , so improving heat treatment conditions is needed.
